# **‘Status of Life in Temporary Shelters’**

Nagapattinam District, Tamil Nadu

July, 2005

**Swayam Shikshan Prayog (SSP), Mumbai,  
The Covenant Centre for Development (CCD), Madurai  
People Science Institute (PSI), Dehradun**

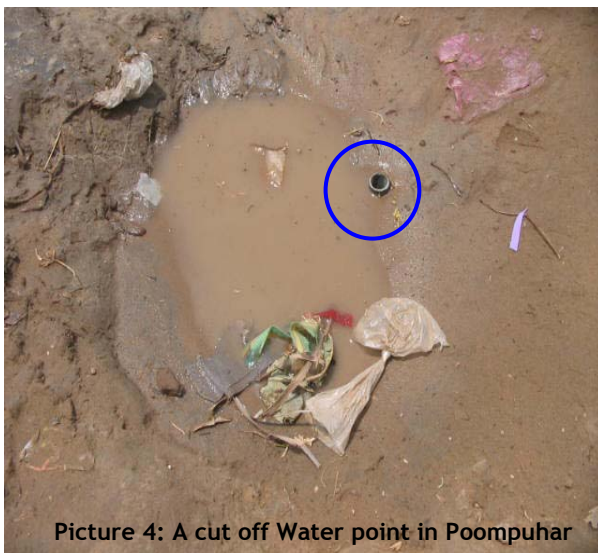
**Picture 4: A cut off Water point in Poompuhar**

like Poompuhar and Vanagiri varied at different points due to technical reasons. Due to pressure differences, as the water flow is less, people (women) have resorted to damaging the taps to fetch water. Often the taps were cut off and closed with wooden stoppers. At times of supply after everybody fetched water, it is a common sight that these leaked and water was

wasted. In many cases women complained of not being able to get water since their allotted water points are defunct and they were not supposed to go to other water points to get water.

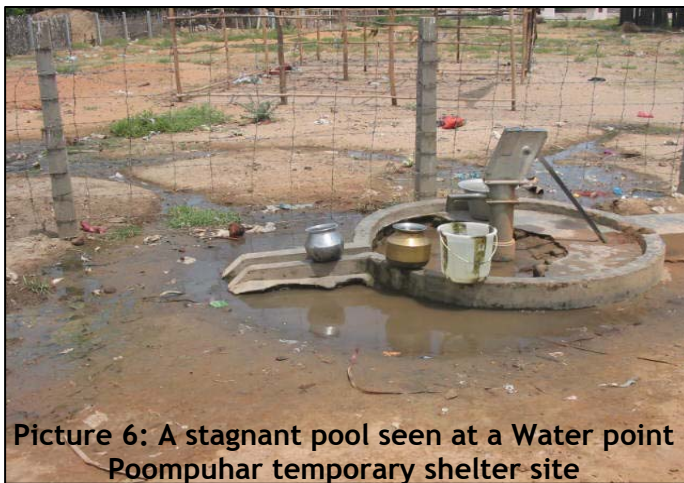
**Picture 6: A stagnant pool seen at a Water point Poompuhar temporary shelter site**

As observed above, the waste water disposal from the water points is very inefficiently managed in many of the sites. No temporary shelter site has drainage except Puthupettai, where they have a small earthen drainage running in front of the shelters,

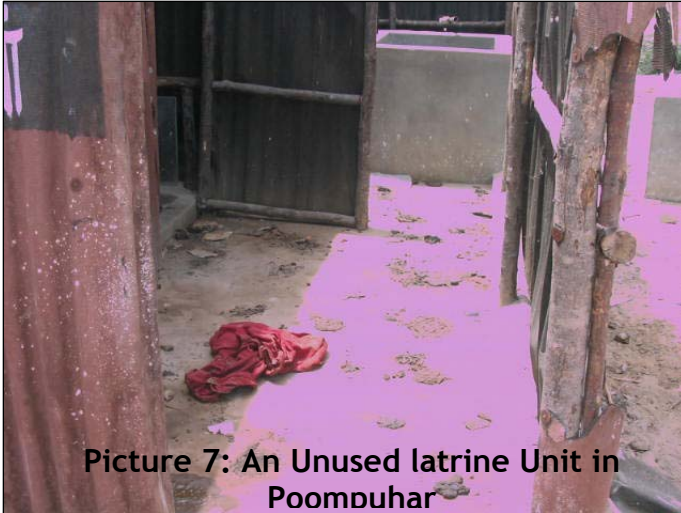
**Picture 7: An Unused latrine Unit in Poompuhar**

Toilet units are present in all the temporary shelter sites. All communities admitted using them for some time immediately after inception. But soon they stopped as there was nobody to maintain them. The toilets now lay in a pathetic condition, with night soil remains seen up to the

entrance. Community sited lack of water and privacy as reasons for not using it. When probed further, they agreed that the main reason had been lack of maintenance and monitoring. In most cases, small children dirtied the toilet seats and pans and came out and nobody cared to clean them and slowly each unit became obsolete. Child friendly toilets and toilet education programs were completely absent from the sanitation plans of the sites.

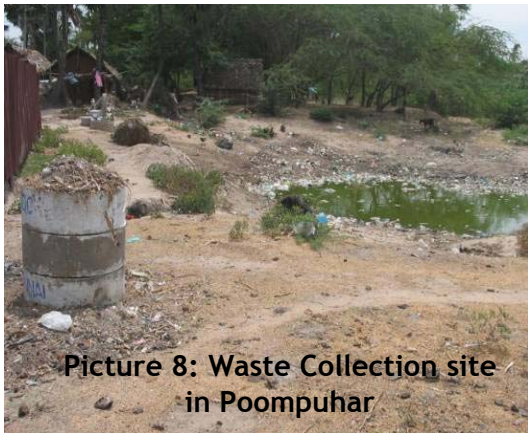
**Picture 8: Waste Collection site in Poompuhar**

and paper waste generated from the households. The communities are well aware of the problems caused by the waste. Several NGO's for that case, had installed garbage bins in the temporary shelter sites in close proximity with the temporary shelters, which was often in the form of concrete rings, two or three in number, placed one over the other.

The panchayat and talukas authorities were seen as incompetent or lacked resources to remove the accumulated waste in regular intervals and the dustbins played out as a reason for community conflicts. The following figure (figure 6) depicts the scores of different villages for solid waste management, based on infrastructure, institutions and status of solid waste management systems. It observed that only four out of the 11 villages in the study attained a benchmark score, implying a requirement for more focussed actions to improve the situation.

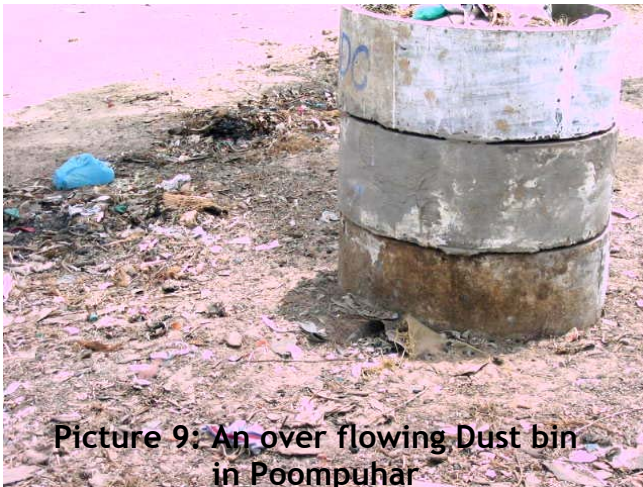
**Picture 9: An over flowing Dust bin in Poompuhar**

Communities who lived next to the dumpsters had issues with accumulating waste in the waste bins. They often objected others from depositing waste in these, because it generated unhygienic conditions near to their residence. It was also observed that the garbage bins

were used initially for some time and then taken out of use. Still in some locations, people throw their waste in the garbage bins or near them in case they are over flowing. In some villages they said they burn the waste once the bins are full. But as of now, almost all of the dust bins remained filled and overflowing, with over a month of waste accumulated in them

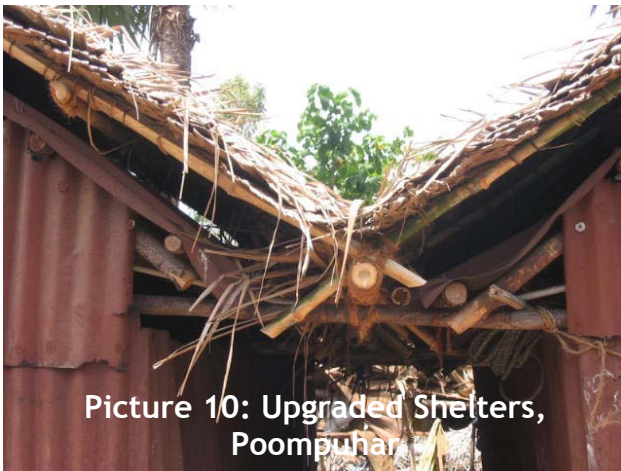
The recent process of upgrading the temporary shelters with thatch (weaved coconut leaves) has created a high risk of fire in almost all the villages. The thatching of the roofs was undertaken after the recent rains to cut the leakages in the asphalted sheet roofs as well as to provide some kind of thermal comfort in the hot summer. The asphalted sheets themselves being not fire proof, contrary to the popular belief, for which they are fire resistant for definite. This means to say that the material takes extended time, under exposed flame to catch fire. But once caught fire, it's very hard to stop the fire. The asphalt or tar, which is a petrochemical by product, flames with vigour once it melts in the heat of the flame. However, the story of over 2,000 temporary shelters gutted in by fire in Chennai and about 500 in Akkarapettai of Nagapattinam district made merely low profile news and risk of fire is still an underlying concern of living in these shelters.

The thatching program, undertaken through tendering process through the Panchayat unions, in the region has covered almost all the shelters in the region. Exposed thatch is very easy to catch fire and they can spread in no time to other shelters as in most cases the shelters were located so close by. In many cases the thatches on two structures meet each other at the end of slopes on both sides. Since most sites don't have continuous supply of water, it will be hard for the residents to control the fire.

- The thermal comfort of the temporary shelter needs to be addressed using viable as well as safe alternatives. The use of thatching, though effective, considerably raises the risk to life and property from fire hazard

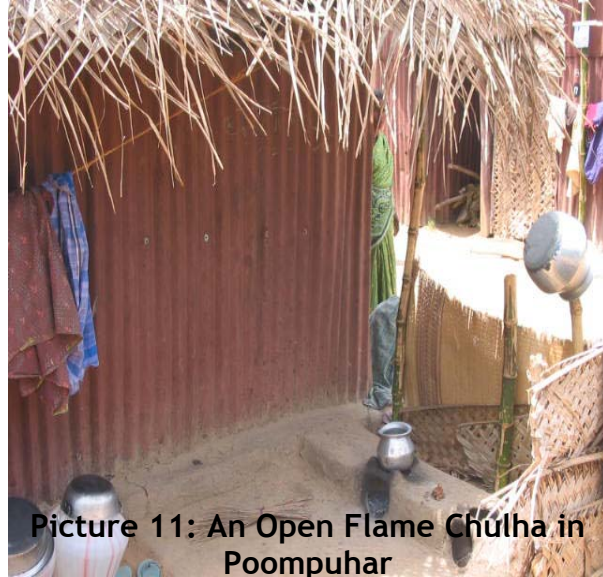
**Picture 11: An Open Flame Chulha in Poompohar**

Two definite sources of risk were, open choolah's, and exposed electrical connections. Leaving the open flames unattended while cooking and not extinguishing the fire after cooking can prove to be costly mistakes in the given conditions. The over loading of the electrical supply lines with the use of appliances ranging from radio's to music systems to grinders to

televisions and fans could lead to overloading and short circuits, which is a most common reason for all kinds of fire accidents.
